THE CONSERVATION PROJECT OF THE MANILA DAGUERREOTYPES

Caroline Barcella
5th Cycle Andrew W. Mellon Fellow
Advanced Residency Program in Photograph Conservation

George Eastman House
Image Permanence Institute

2009

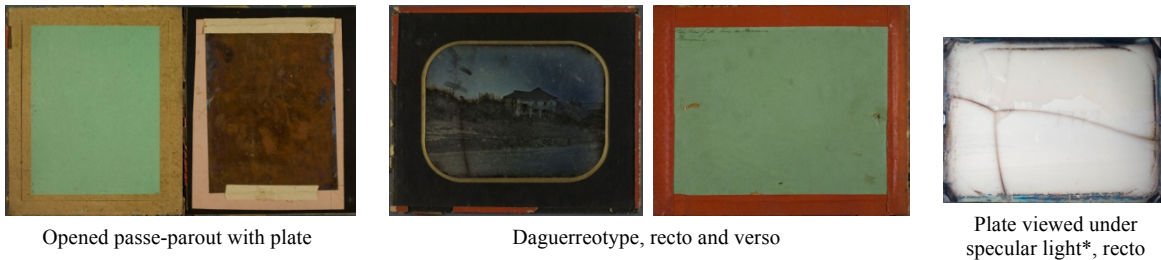
Two housings consist of a cover glass over a paper mat bound with a red tape to the board. Inside, the plates were secured with strips of adhesive paper. The tape and the paper mat appear to be from a later period when compared with the original housings. However, the boards are similar. Therefore, it seems that the cover glass and the paper mat are later additions. Confirmation of this hypothesis is found by examining the plates themselves. One shows tarnish lines that indicate the presence of cracks in a previous cover glass, and both show tarnish lines following the shape of an octagonal window opening, when the present mat opening is rounded at the corners. Furthermore, the plates show residues of wax on the back, indicating that they were originally secured in the same way as the plates kept in their original painted glass housings.

* The view under specular light shows tarnish lines following the shape of the breaks in a former cover glass

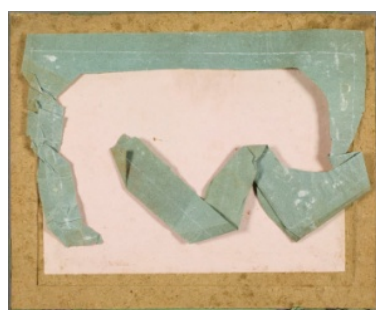
L2007:0328:0005

Overall, two cover glasses were missing, and two others were broken (Figure 22).

Figure 22: Housings with missing or broken cover glasses

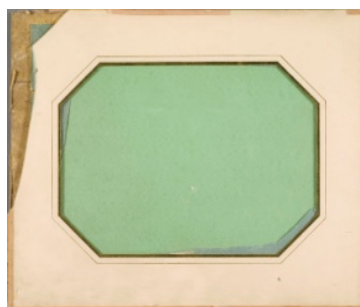
The broken painted glass L2007:0328:0017 was purposely not cleaned to retain an example of the original condition of the objects before treatment. It was secured in a transparent housing that allows examination of the entire object from the recto and the verso. The design was developed by ARP Mellon Fellow Mari Miki. Further information can be found in the associated treatment report.

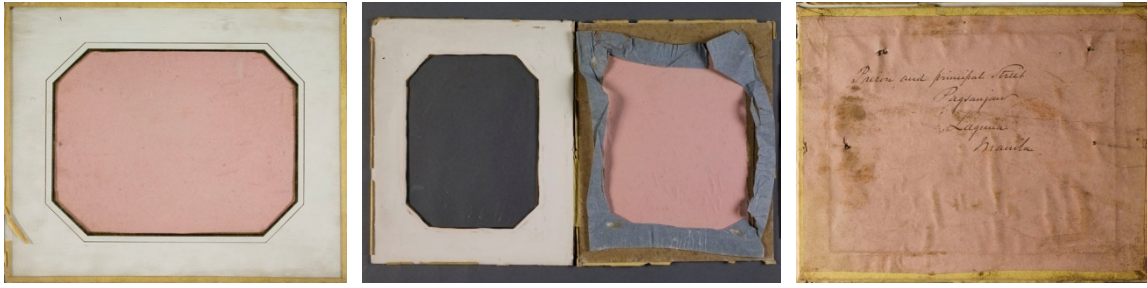
L2007:0328:0009

All of the housings were severely soiled, with failed sealing paper tape leading to the complete or partial detachment of the glass and the board. All of the cover glasses had some level of glass deterioration, manifested as crystal formations visible under low power microscope examination. A form of glass deterioration, appearing as interference colors, was found on most cover glasses. The white and pink reverse painting on glass revealed small losses and a powdery surface (Figure 23).

Figure 23: Deterioration of the housings

Glass corrosion is a common deterioration found on the internal side of cover glass for daguerreotypes and can be attributed to periods of high humidity inside the housing system (PPMC, 1998, p. 7; S. Barger and W. White, 1991, pp. 174-181). The losses in the reverse painting on glass are caused primarily by contact with the point of the pins penetrating through the board (see chapter I paragraph 1.2). Other losses are due to the friable nature of the paint composition.

The powdery surface of the white and pink paint was consolidated by spraying several layers of Lascaux® Fixativ 2070 in spray (2% Paraloid B-72 in xylene/isopropanol); the window opening was masked off. Consolidation was successful and neither color shift nor tide lines were observed.

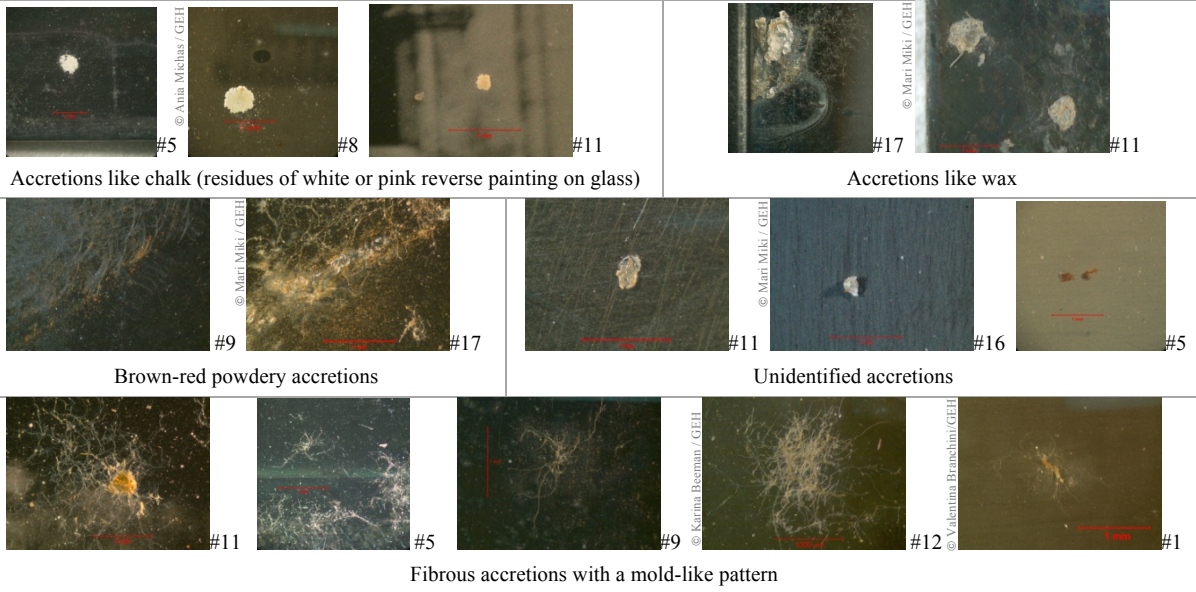
Figure 24: Accretions

Accretions of various types were found on all of the plates. Residues of the reverse painting on glass were identified on most plates housed in white or pink reverse painted glass. Fibrous accretions with a mold-like pattern were found on all of the plates, located on the perimeter. We notice that the plate housed in a passe-partout with additional bevel mat shows the most significant fibrous accretions, which also appeared beneath the crack of the cover glass (plate # 11).

Accretions are primarily from the powdery surface of the paint or infiltration of dust due to the failure of the protective housings. Fibrous accretions are likely to be mold, as they show the distinctive characteristics of fungi and are located in the areas where the plates were most exposed to humidity (along the edges and under cracks of the glass). The fact that the most mold-like fibrous accretions were found on the plate having greater internal air volume than the others (due to the greater thickness of the beveled mat) tends to confirm this hypothesis.

The plates were dusted with blown air using a rubber bulb to remove loose accretions. The most significant accretions still adhering to the surface were partially or totally removed with the brush Isabey Repique Kolinsky (6229) size 0 under stereomicroscope. Intervention in the highlights of the image was minimal, as the risk of micro abrasion is high. Brush strokes always followed the direction of the polishing lines.

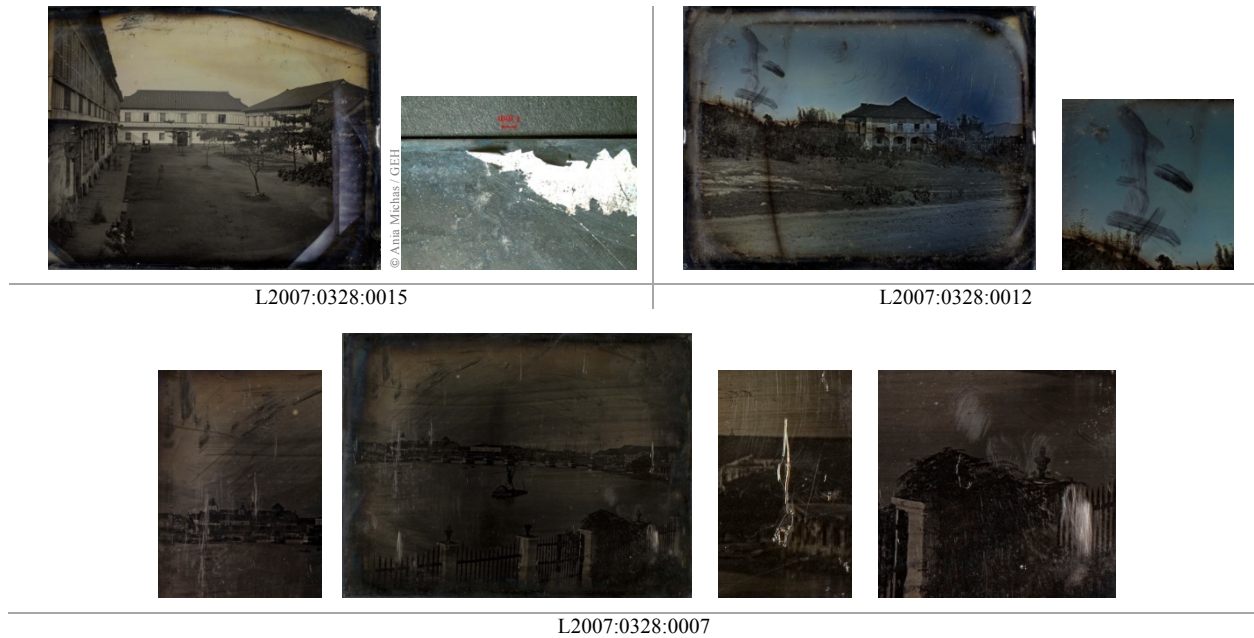
Figure 25: Examples of physical deterioration

Two plates showed exfoliation of the silver-plated layer, and one was bent.⁷ Contact with the plate surface caused abrasions and significant losses in some of the plates (see Figure 25 below).

Direct contact with the plate surface is the major source of mechanical damage, caused by poor handling and/or failure of the protective housing.

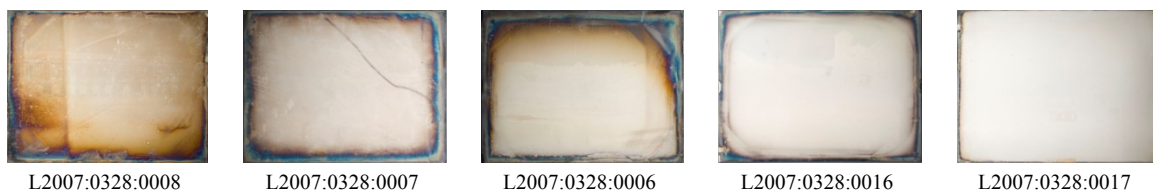
Figure 26: Tarnish films (plates viewed under specular light)

Plates were in various chemical conditions. Some showed very little tarnish; others presented an overall tarnish film and various tarnish spots. Interference color fronts along the edges and following the shape of the window opening were present in most cases.

Tarnishing of the plates is due to their exposure to air pollutants and humidity, and the degree of tarnish is usually greater for plates with failed housing systems. Residual products from variations in original processing treatments contributed to chemical deterioration as well.

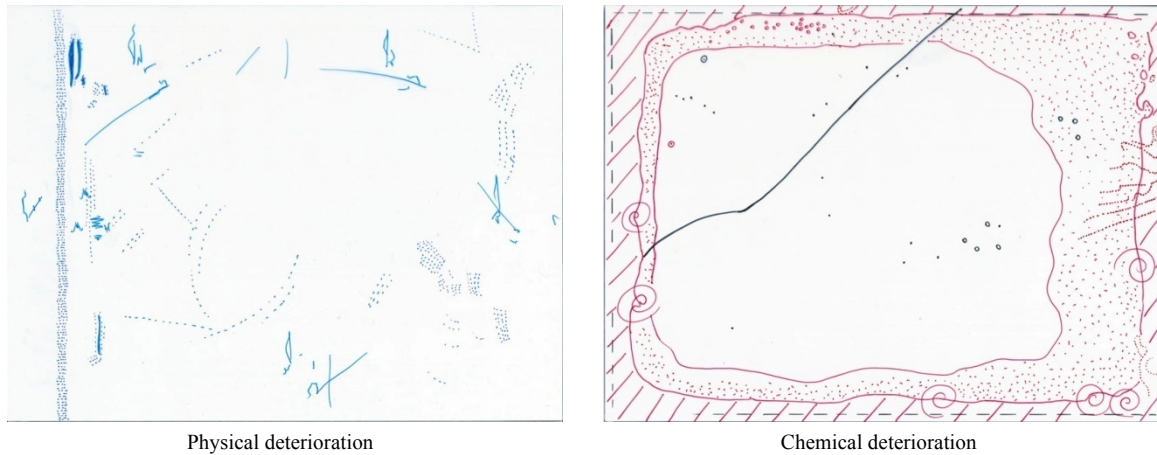
Figure 30: Graphic representation of deterioration (L2007:0328:0007)

representation of deterioration. The surface condition, the physical deterioration, and the chemical deterioration were successively mapped on a Mylar sheet with uniform color code and symbols, and inserted as images in the report (see example in Appendix 4).

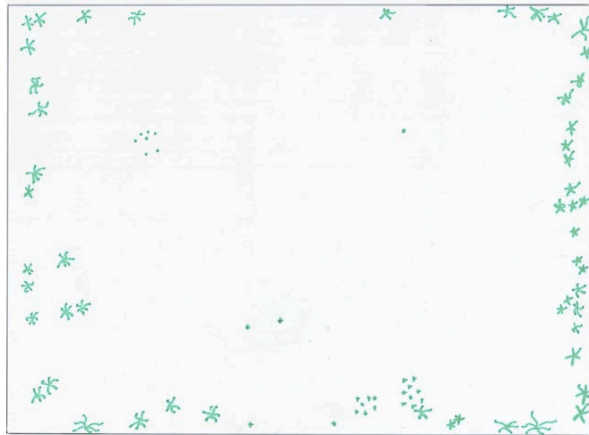
Surface condition

1. + WHITE ACCRETION
 0 BROWN ACCRETION
 2. * FIBROUS ACCRETION
 ONLY BIGGEST ACCRETIONS ARE REPRESENTED (NOT IN SCALE)

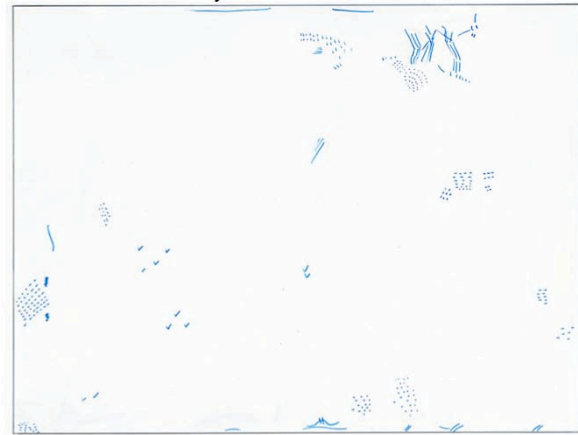
Physical deterioration

5. ... ABRASION
 9. # LOSS
 10. V PITTING
 11. # PLANAR DISTORTION
 12. / SCRATCH

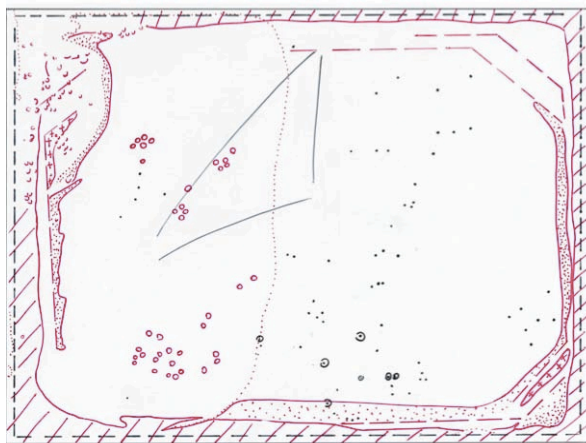
Physical deterioration

TARNISH:
 15. 0: CORROSION SPOT
 16. (brown/yellow circle): BROWN/YELLOW
 18. (interference circle): INTERFERENCE COLOR
 19. CLOUDY FILM
 (white circle): WHITISH
 (blue circle): BLuish

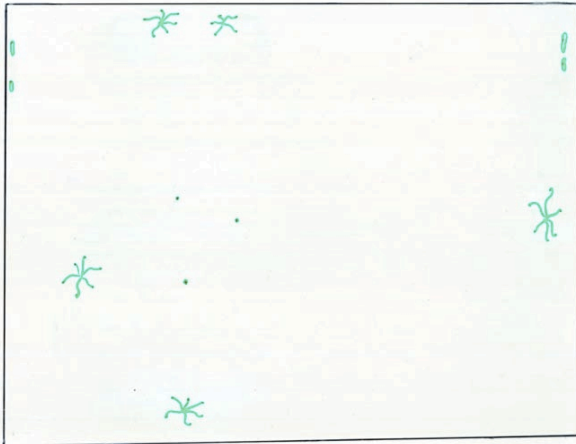
Surface condition

- 1. • ACCRETION
- 2. * AREA OF FIBROUS ACCRETIONS
- 3. ○ RESIDUE

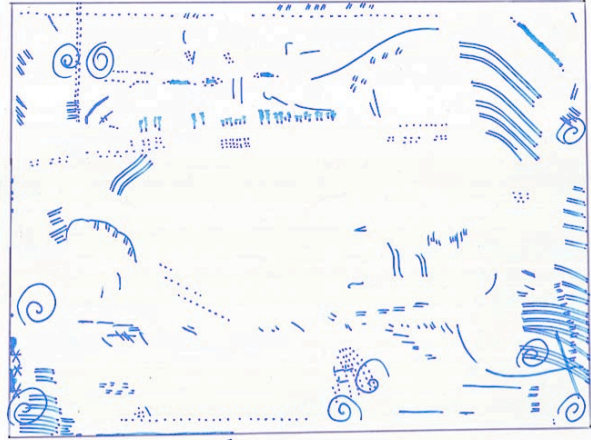
Physical deterioration

- 5. --- ABRASION
- 8. * EXFOLIATION
- 9. ○ FINGER PRINT
- 10. • LOSS
- 16. — SCRATCH

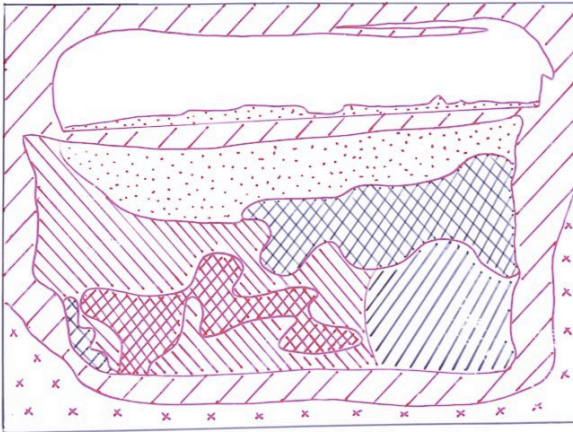
Chemical deterioration 1/2

- TERRACE
- 16. BROWN / YELLOW
 - 17. BLACK
 - 17a. GREY
 - 17b. INTERFERENTIAL COLOR
 - 18. BLUE
 - 18a. PURPLE
 - 18b. SLIGHT CLAY

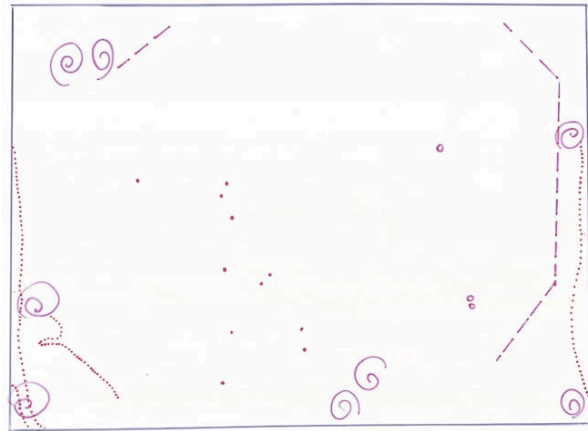
Chemical deterioration 2/2

- 13. • CORROSION STAIN
- 14. ○ FINGERPRINT
- 17. --- TIDE LINE
- 19a. ○ FADED SPOT
- 19b. --- SHAPE OF A MAT
