THE CONSERVATION PROJECT OF THE MANILA DAGUERREOTYPES

Caroline Barcella
5th Cycle Andrew W. Mellon Fellow
Advanced Residency Program in Photograph Conservation

George Eastman House
Image Permanence Institute

2009

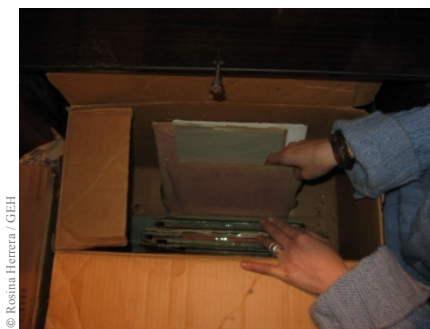
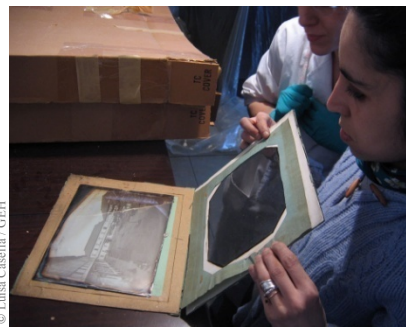
Figure 4: Discovery

Daguerreotypes in their storage box

When the objects were discovered, they were stored vertically in a cardboard box. Several of the plates were separated from their housing (see Figure 4). To provide a more secure temporary environment, the objects were protected in individual 4-flap enclosure and stored flat in cardboard boxes. The bare plates had previously been placed in customized paper trays by ARP Mellon Fellows Luisa Casella and Rosina Herrera to preclude contact of the enclosure with the surface.¹⁵

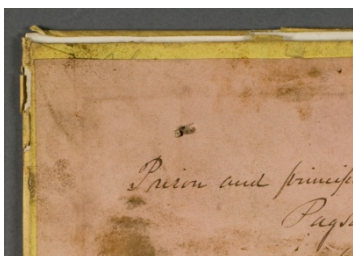
L2007:0328:0009

One of the daguerreotypes of the “Laguna” area also shows two letters in pencil partially covered by the backing paper. As the treatment of the daguerreotypes involved the removal of backing papers, the full letters “CG” appeared. The same initials were found under the backing papers of the three other daguerreotypes of the “Laguna” area.

Figure 13: Inscriptions “CG” and “27 July”

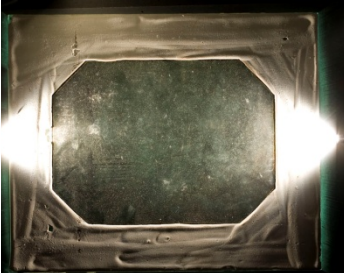
L2007:0328:0009

Figure 23: Deterioration of the housings

The blue paper mat was easily physically damaged because it was thin. It was unable to support the weight of the plate. Staining of the areas of the paper that came into contact with the board indicates the boards' chemical instability and poor quality. The white residues are due to the powdery surface of the reverse painting on glass. The origin of the red powdery residue is undetermined. It may come from the "rouge" (iron oxide) used to polish the plate—possibly a contaminant from the space where the plates were prepared, processed, and put in the original housings.

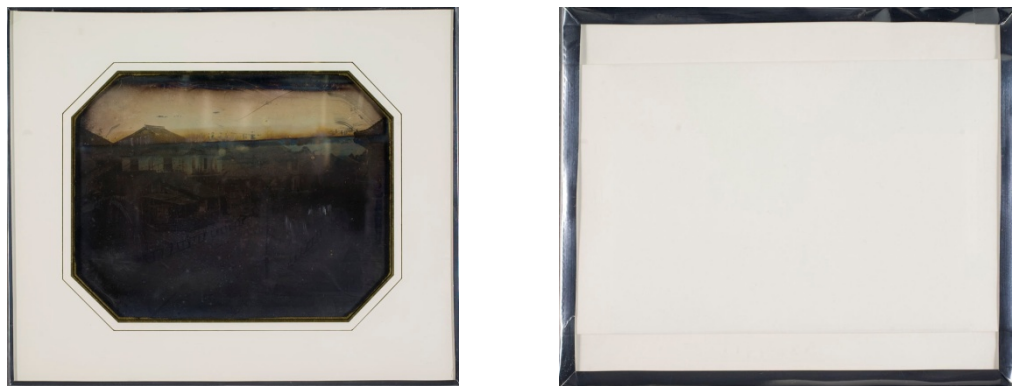
L2007:0328:0009

Figure 32: Securing package

- Assemble cover glass and interlayer paper mat using small tabs of Filmoplast® P-90 on the edges to avoid shifting. Attach the plate in the holder using small tabs of Filmoplast® P-90 on the edges to avoid shifting. Attach the barrier film on the back with small tabs of 3M™850 Silver Polyethylene Tape on the edges. Ensure that the barrier film is taut, with no wrinkles or bulges. Place clamps on the edges to secure the package.
- Bind the package on the perimeter with one continuous strip of 3M™850 Polyester Silver Tape. Repeat the operation going in the opposite direction.

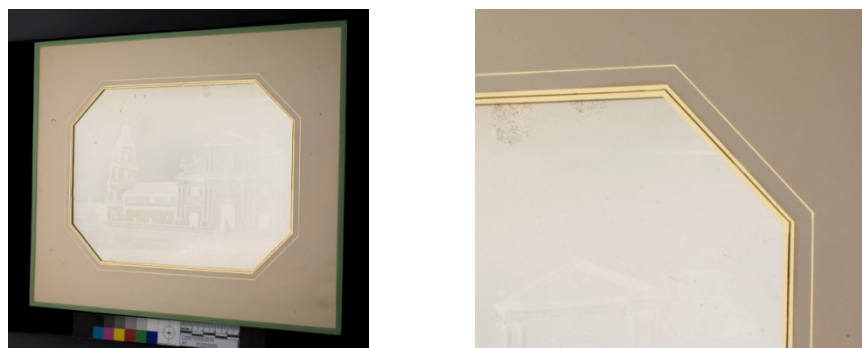
L2007:0328:0014

The gold lines of the original painted glass of the Manila Daguerreotypes show high reflectivity with a mirroring effect, which is characteristic of gold lines made of gold leaf. The design consists of three gold lines and a thin black line following the shape of an octagonal window opening. One broken painted glass was of this kind, and we knew that the two missing cover glasses were very likely to have been made the same way (see part I paragraph 4.2.2). As the gold lines of the original passe-partouts of the Manila Daguerreotypes strongly affect the aesthetic of the objects, it was decided to reproduce them with the same design and the same material. This endeavor was challenging, as no conservation technique was known. After various experiments, a technique from sign painting on glass was adopted.

Figure 33: Gold lines of the original passe-partouts

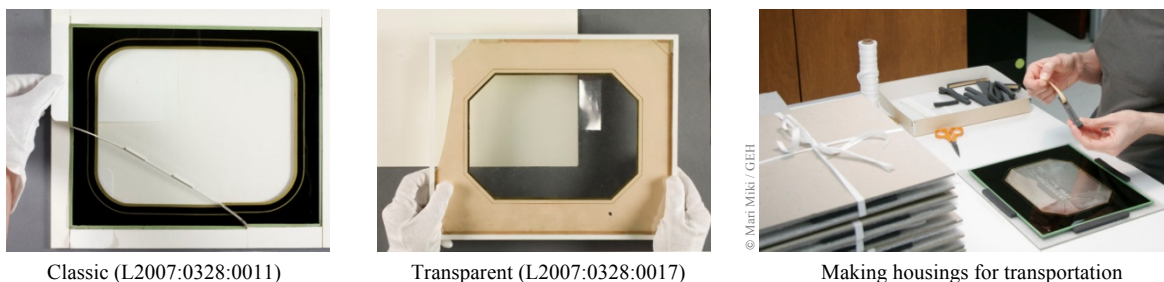
Figure 48: Secondary housings for broken painted cover glass and transportation

The broken painted glass L2007:0328:0017 was purposely not cleaned to retain an example of the original condition of the objects before treatment. It was secured in a transparent housing that allows examination of the entire object from the recto and the verso. The design was developed by ARP Mellon Fellow Mari Miki. Further information can be found in the associated treatment report.

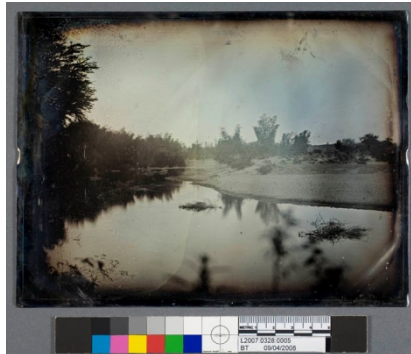
Recto of the plate, before treatment

3. <u>residue</u>	
4. <u>other</u>	
<i>Physical deterioration:</i>	
5. <u>abrasion</u> : moderate. 2 distinct abraded and scratched areas in the C and R top, possibly due to surface contact with the mat.

The plate is physically and chemically secured in its original housing. All the elements of the housing were stabilized and reused when reassembling the package, except the failed binding tape and blue interlayer paper (both are enclosed inside the package). The missing cover glass has been identified as a reverse painting on glass, and reconstructed based on the design of the other painted glass of the *Manila Daguerreotypes*.

The plate, originally fixed to a thin blue paper by dots of wax (the failure of which caused shifting) is now held in a paper double tray. As humidity and pollutants contained in the air cause chemical degradation of the daguerreotype, the plate was isolated from the exterior atmosphere inside a semi-sealed package. The backing board was then attached using a paper tape tinted in the same color as the original.

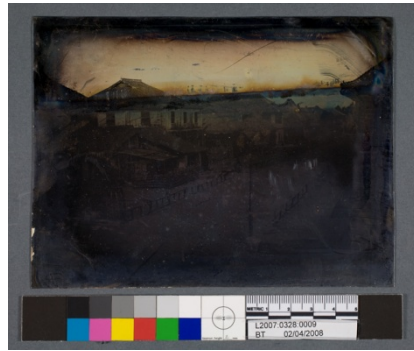
Recto of the plate, before treatment

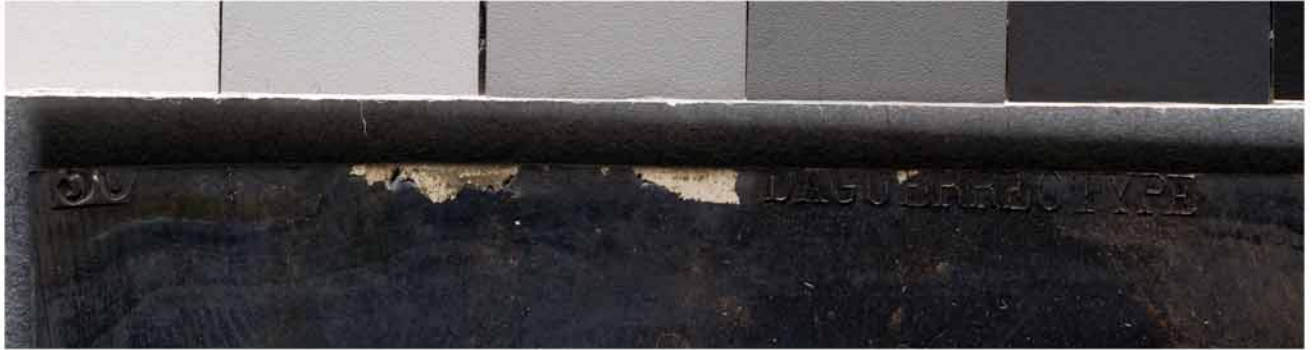
L200703280009_BT_PLATE_RAK_exfoliation & hallmark_BLC.tif
